Predicted Effects of the Cascadia Earthquake Clallam County

by
Jim Buck

Study Conducted by the Department of Homeland Security's Homeland Infrastructure Simulation and Analysis Center (HITRAC)

Based on the Cascadia Regional Earthquake Workgroup 9.0 Earthquake

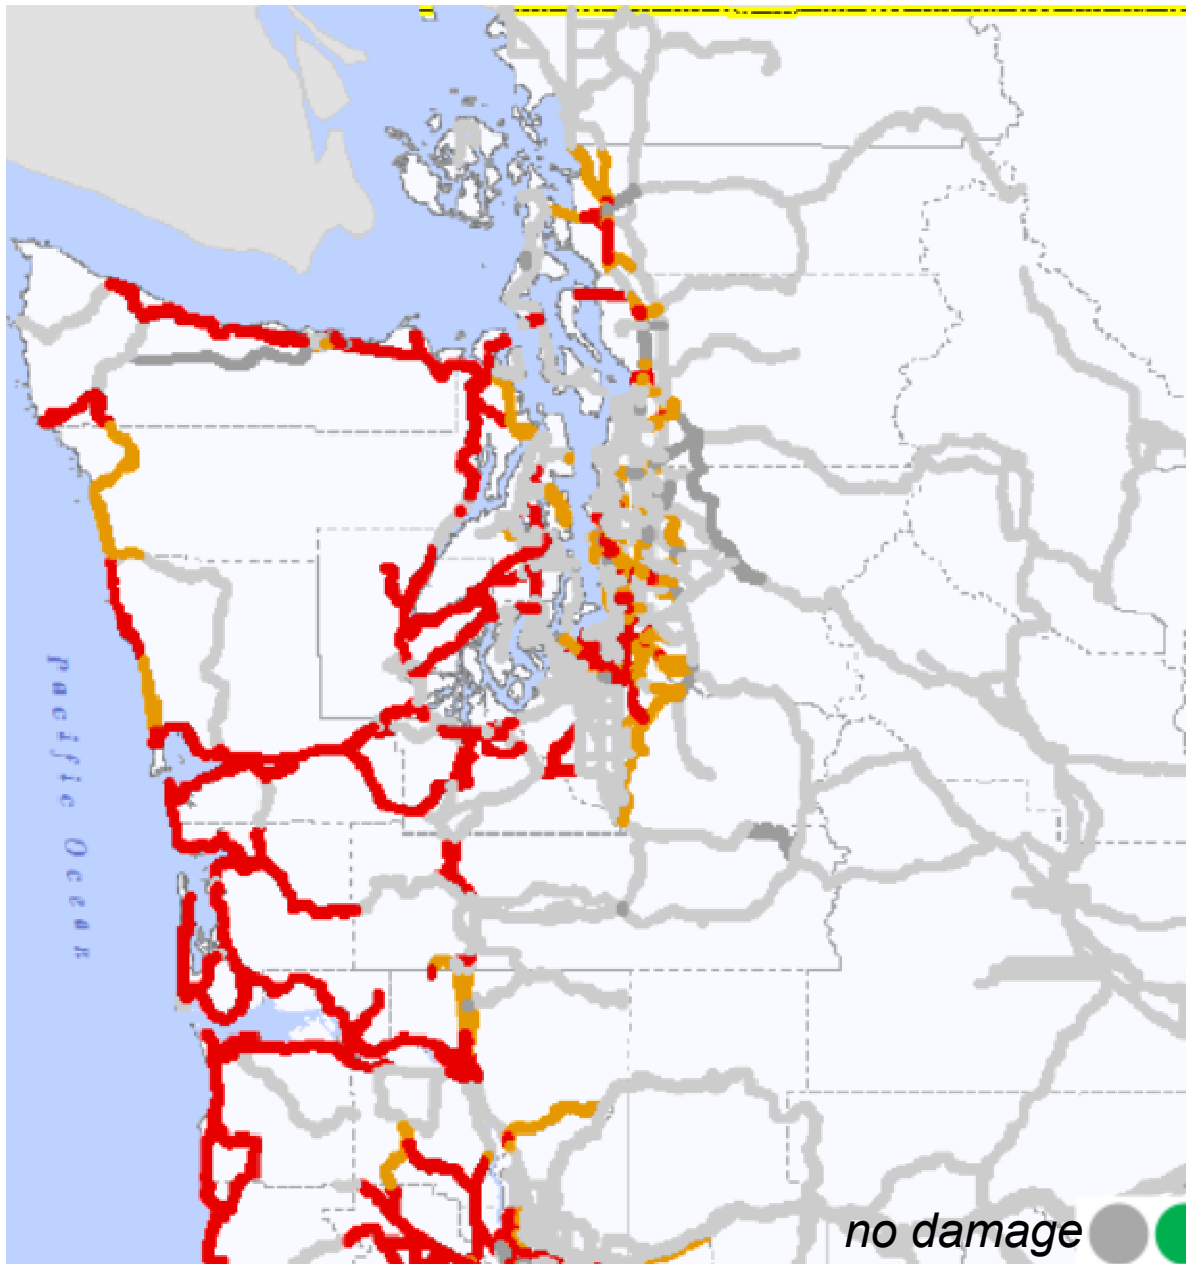
HIGHWAYS

The highway system will suffer the most damage in the vicinity of the coast from both earthquake and tsunami damage.

There are no surviving ground routes to the coastal region.

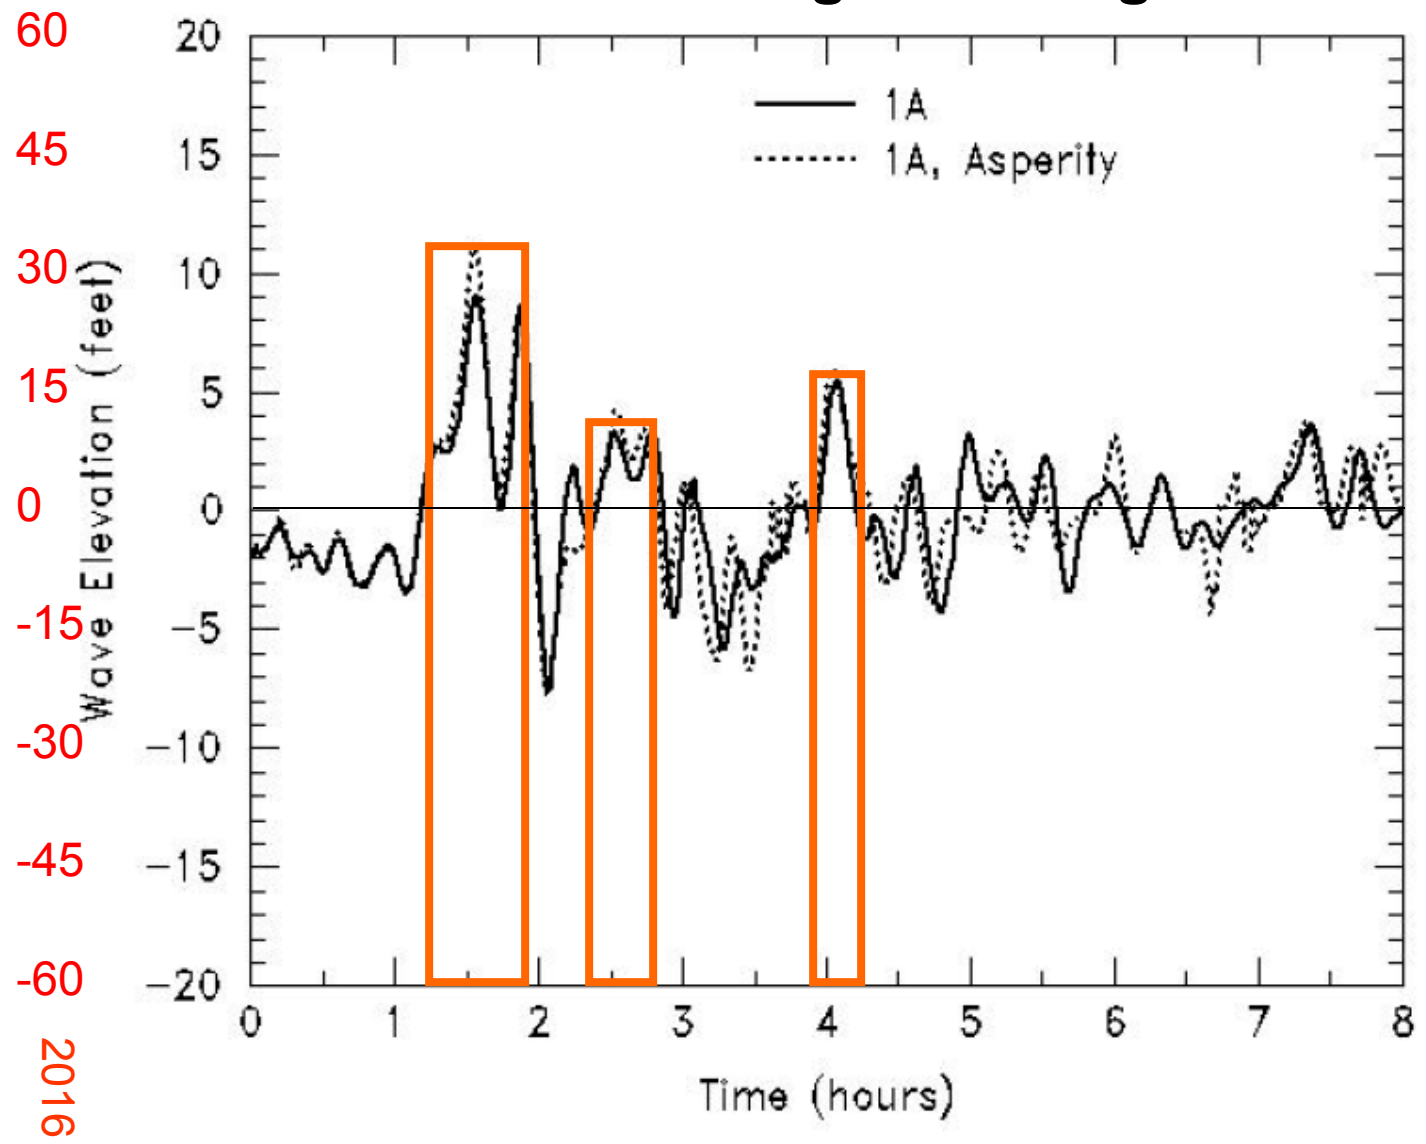
Tsunami Timing - Port Angeles

Figure 3. Elevation time history of tsunami waves in open water near Ediz Hook. Negative numbers indicate water moving out and positive numbers are water moving in

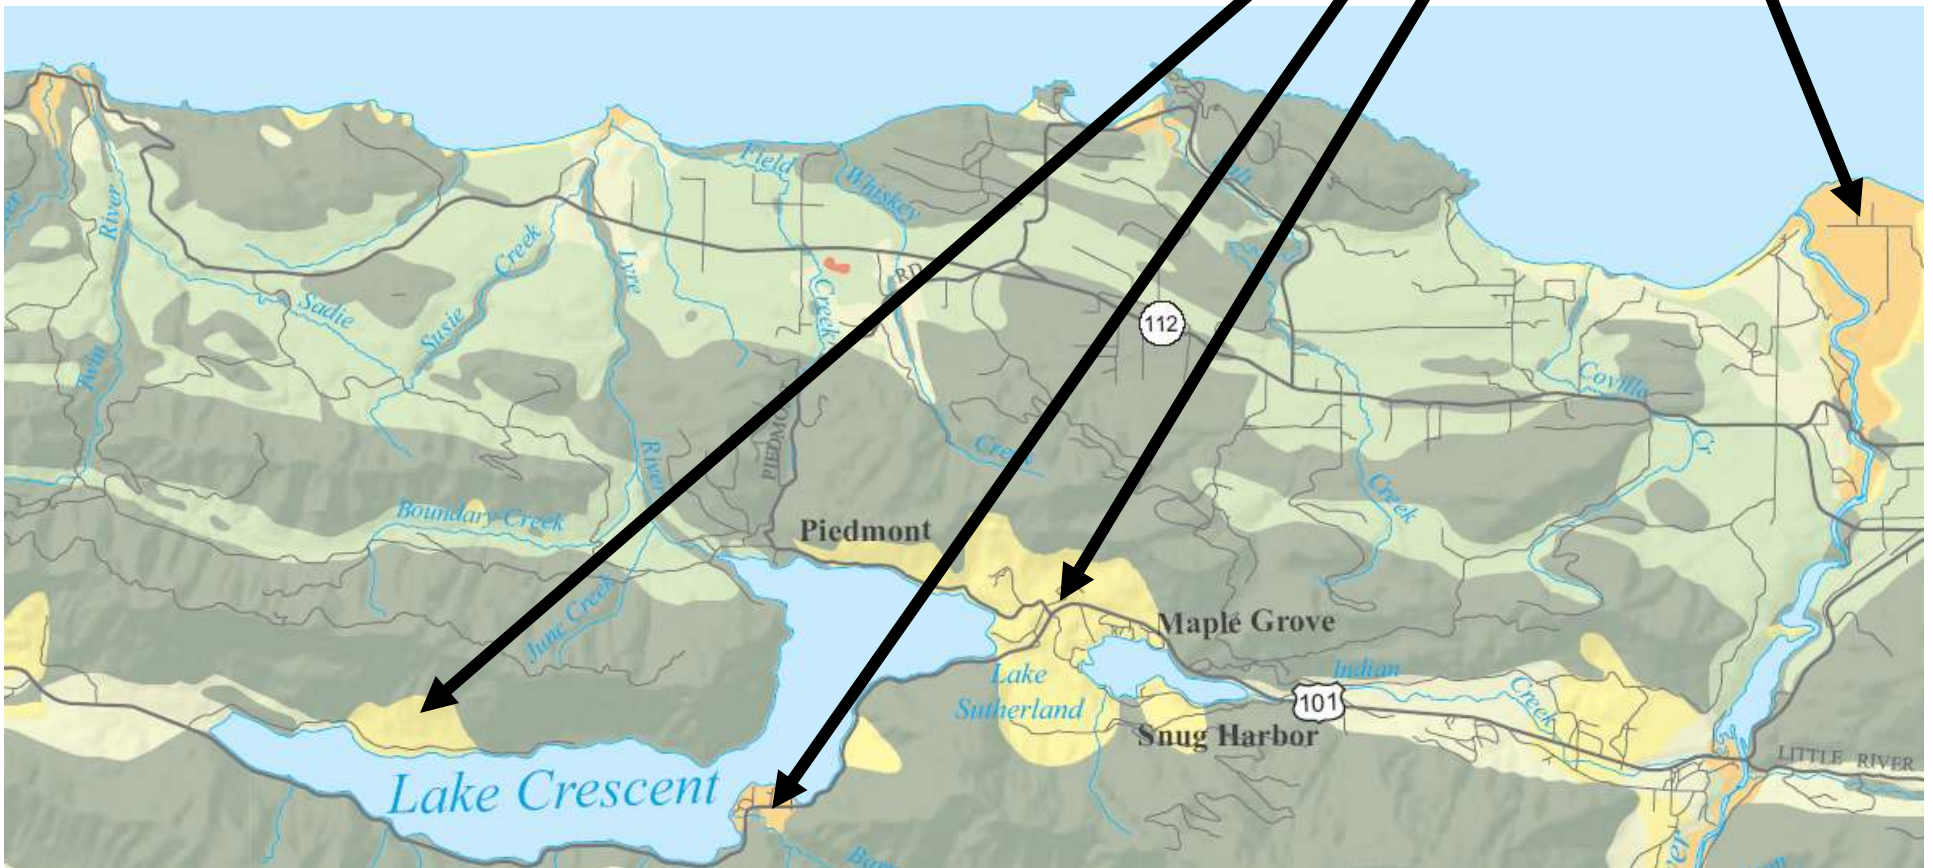
Ground Shaking – Elwha to Twin

Note the Seiche Potential on Lakes Crescent and Sutherland

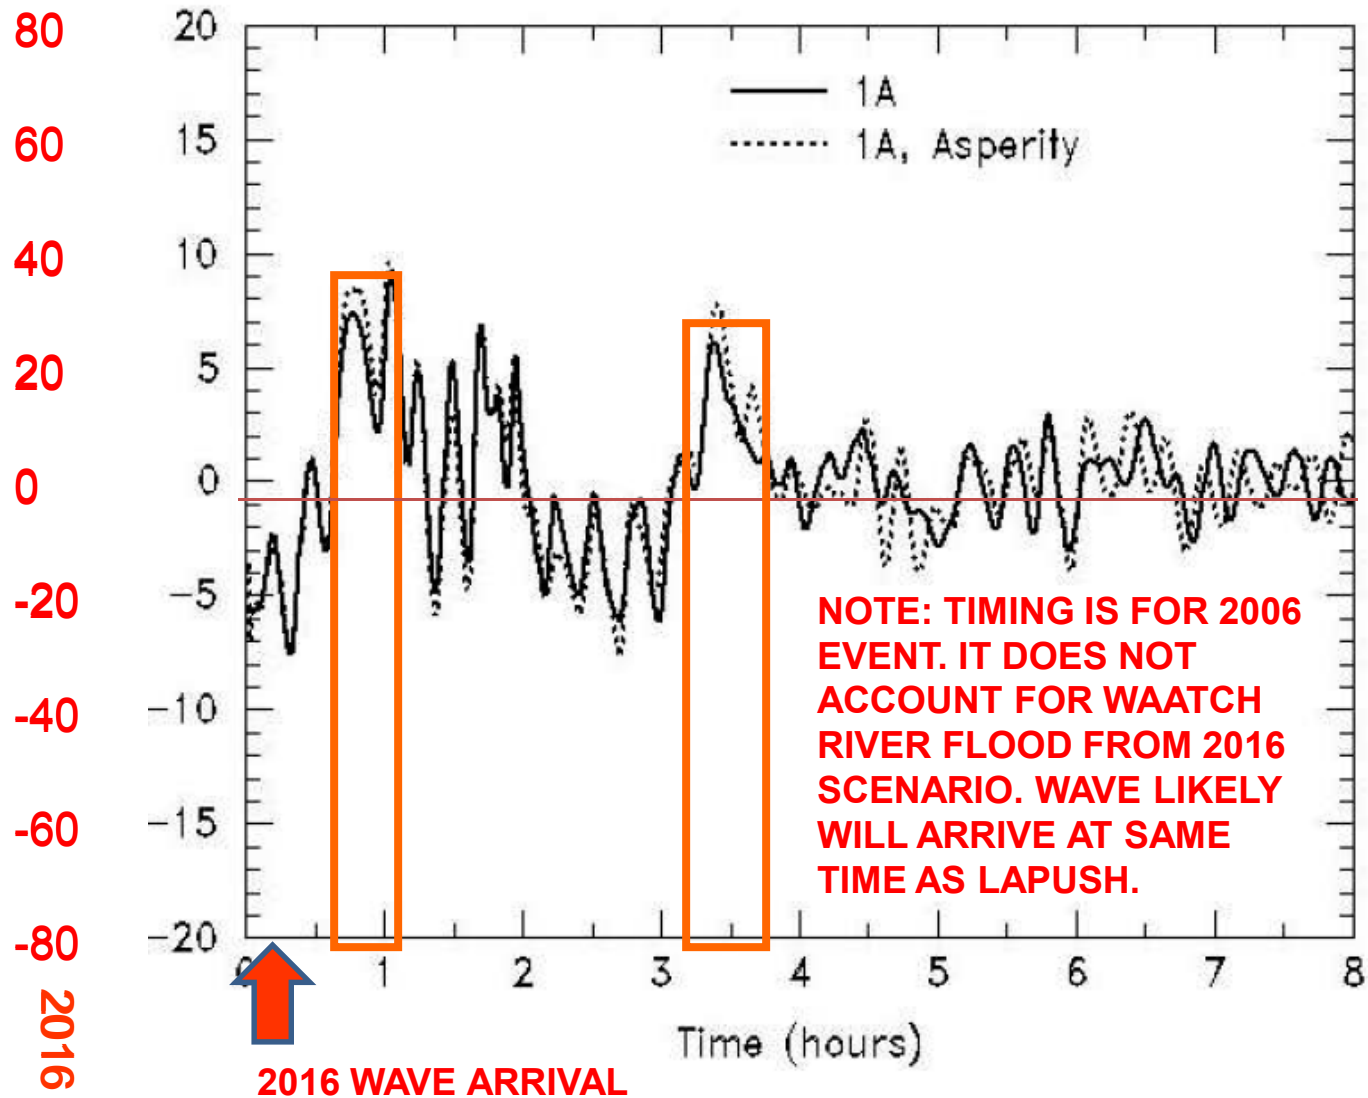
Tsunami Timing - Neah Bay

Figure 3. Elevation time history of tsunami waves in open water near Neah Bay. Negative numbers indicate water moving out and positive numbers indicate water moving in.

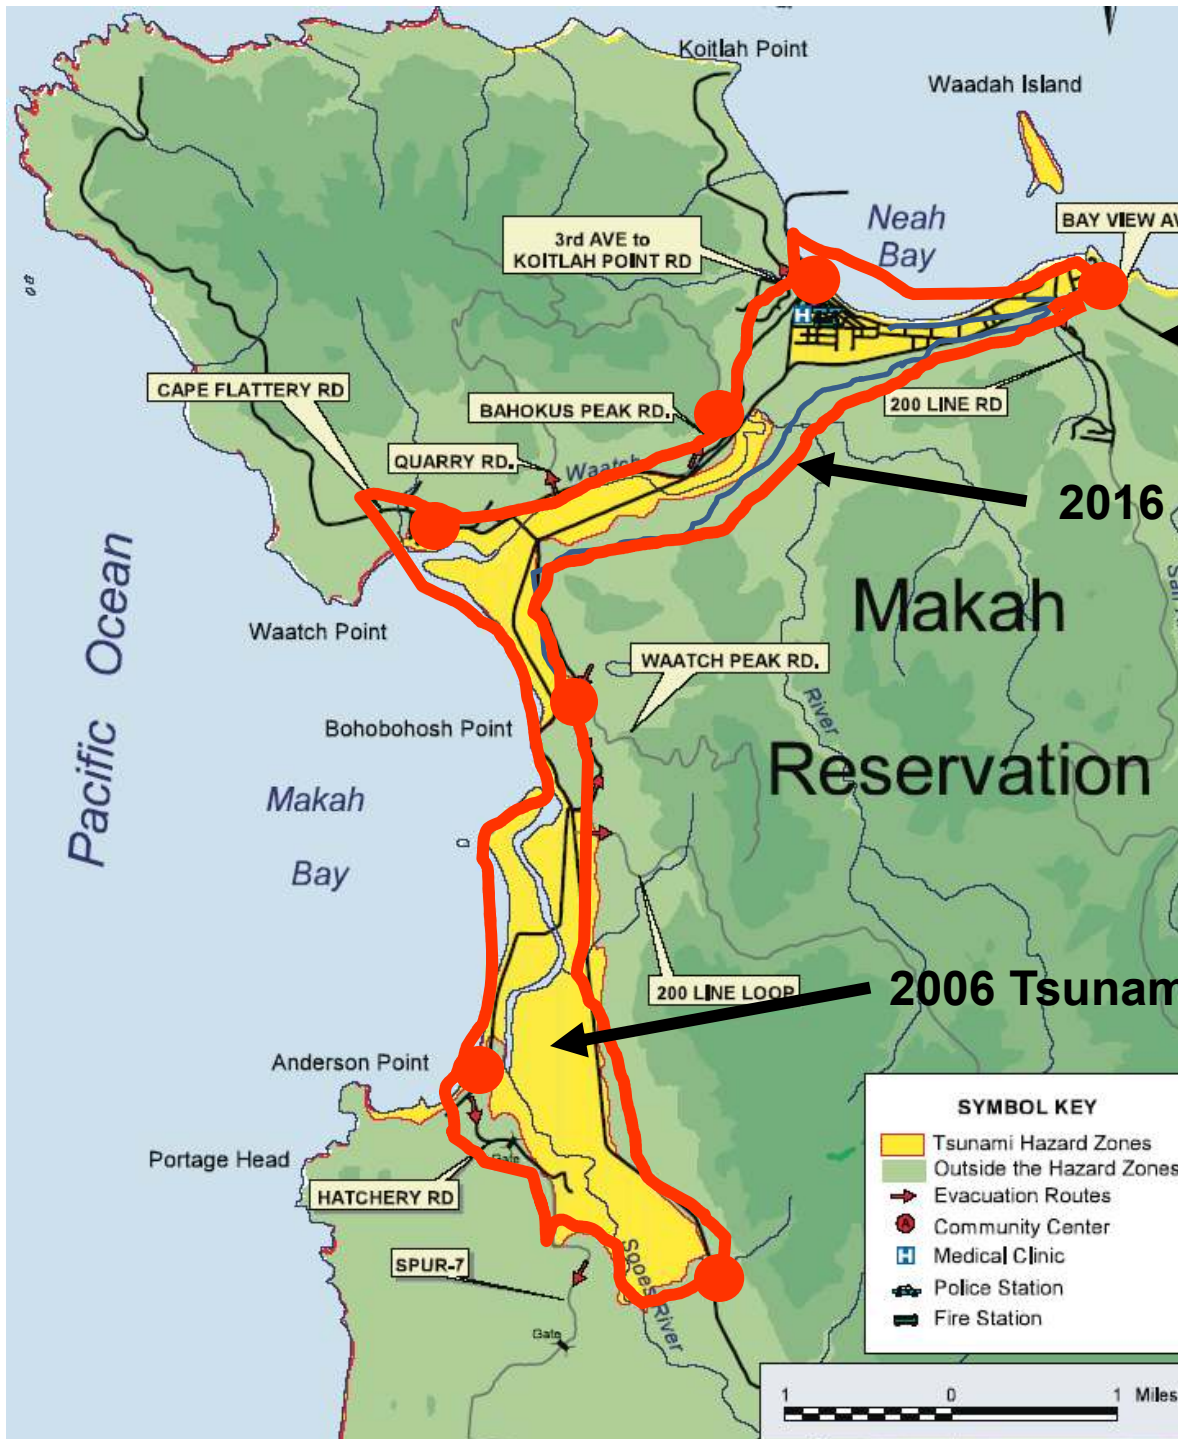
Summary of Damage Neah Bay

Highway 112 Impassible to Sekiu River due to slide and tsunami Debris

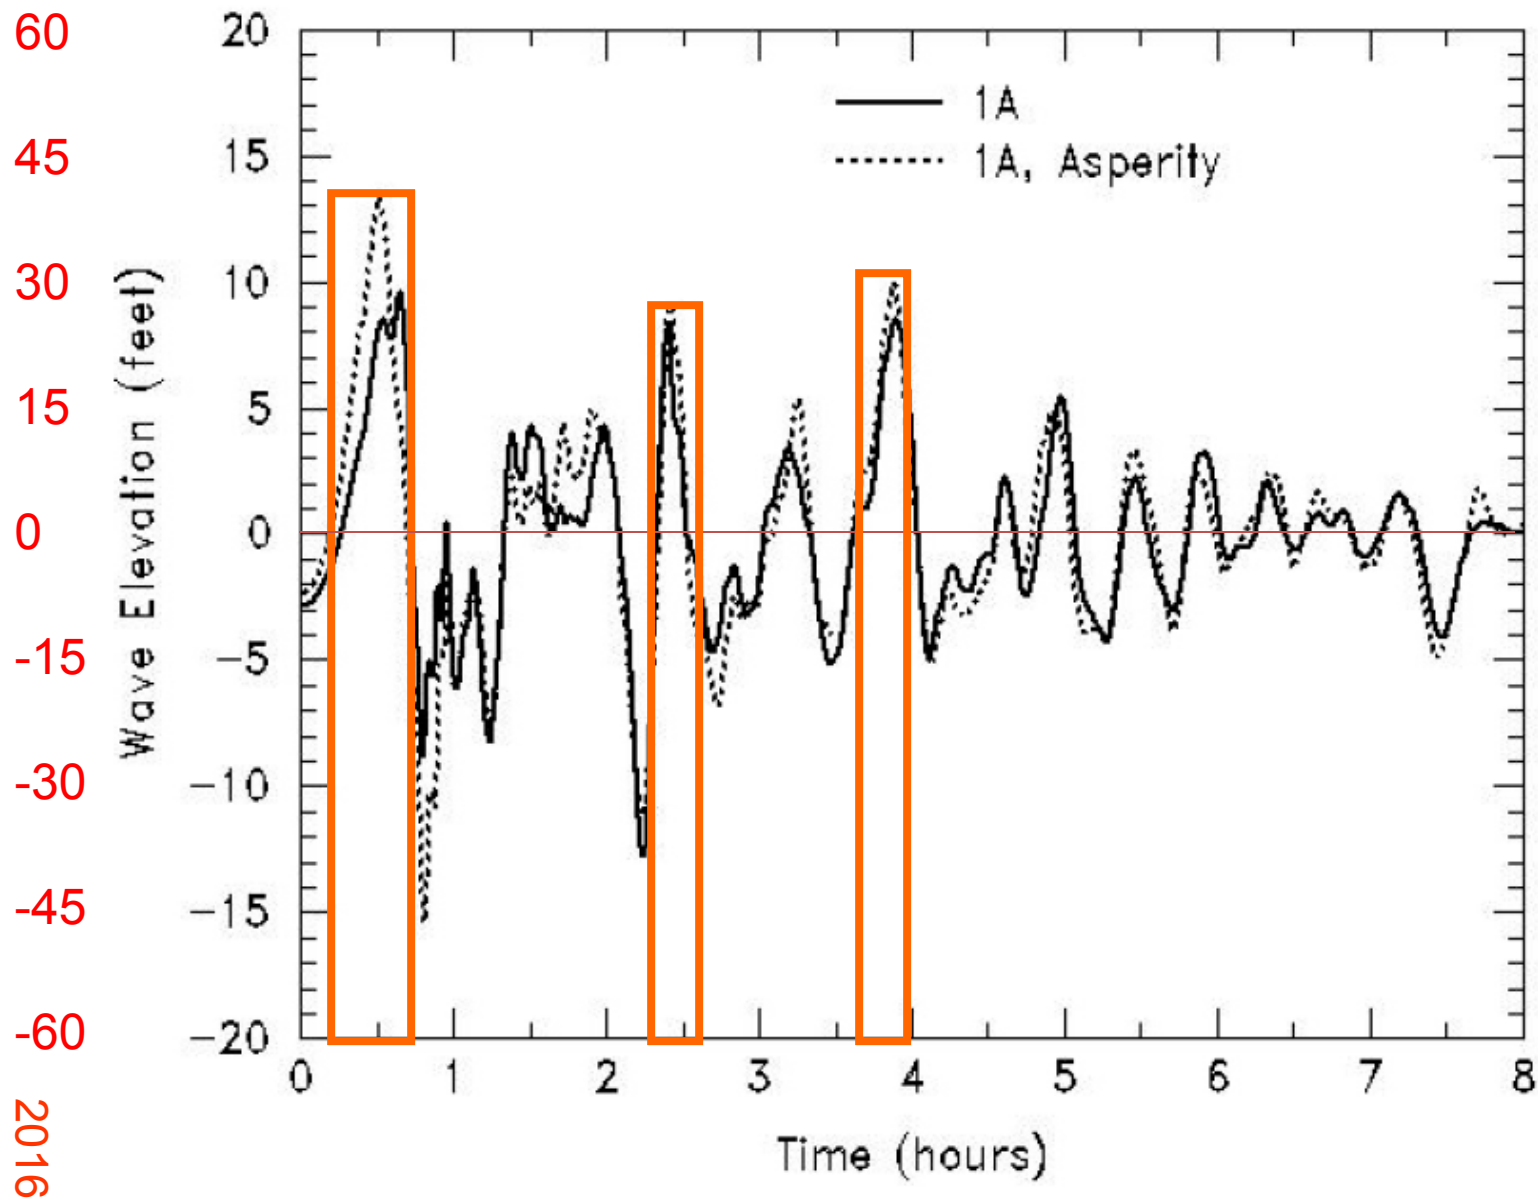
Tsunami Timing - La Push

Figure 3. Elevation time history of tsunami waves in open water off the Quileute Reservation. Negative numbers indicate water moving out and positive numbers
